Durand Eastman Beach Outfall Project
City Project # 14329
NYDOS Contract C006967

**Lakeshore Boulevard over
Sherry Swamp Outfall**

CULVERT INSPECTION REPORT

**Culvert Inspection Report
Lakeshore Boulevard over Sherry Swamp Outlet**

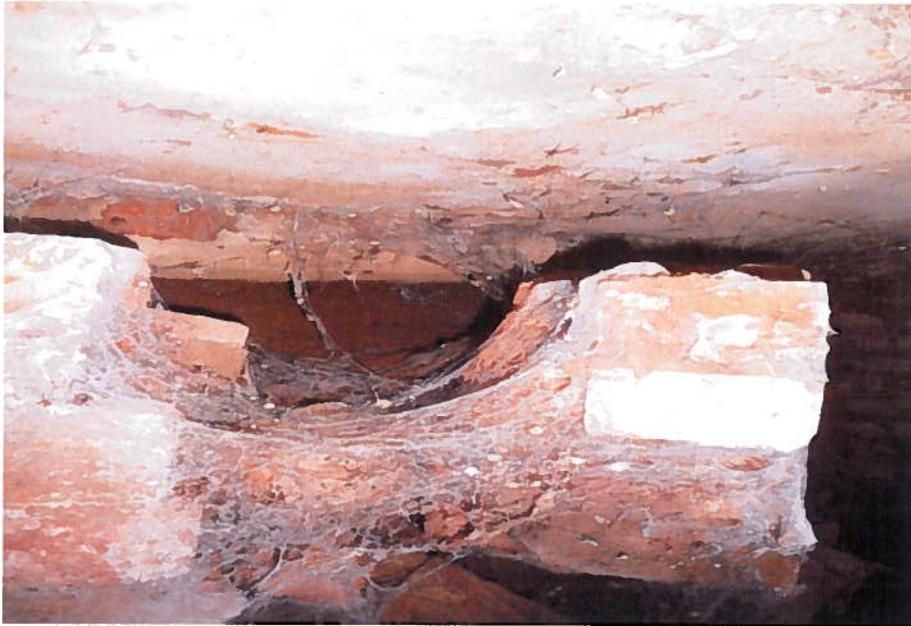
Manhole #1 is in poor condition. The north wall has been displaced 2'-0" into the manhole exposing the earth fill material and compromising the support of the roof slab. A full height vertical crack was observed in the west wall face of the structure.

Photo # 1: Manhole no. 1, north wall displaced inward, no longer supporting roof slab

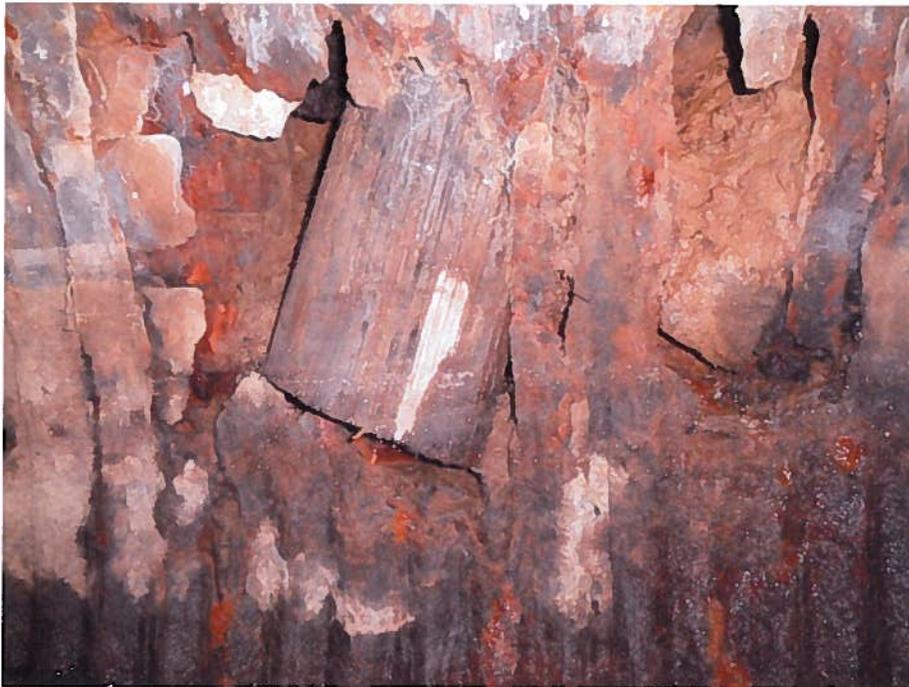
Photo # 2: West wall, sta. 1+05, 100% section loss in cmp, water infiltration

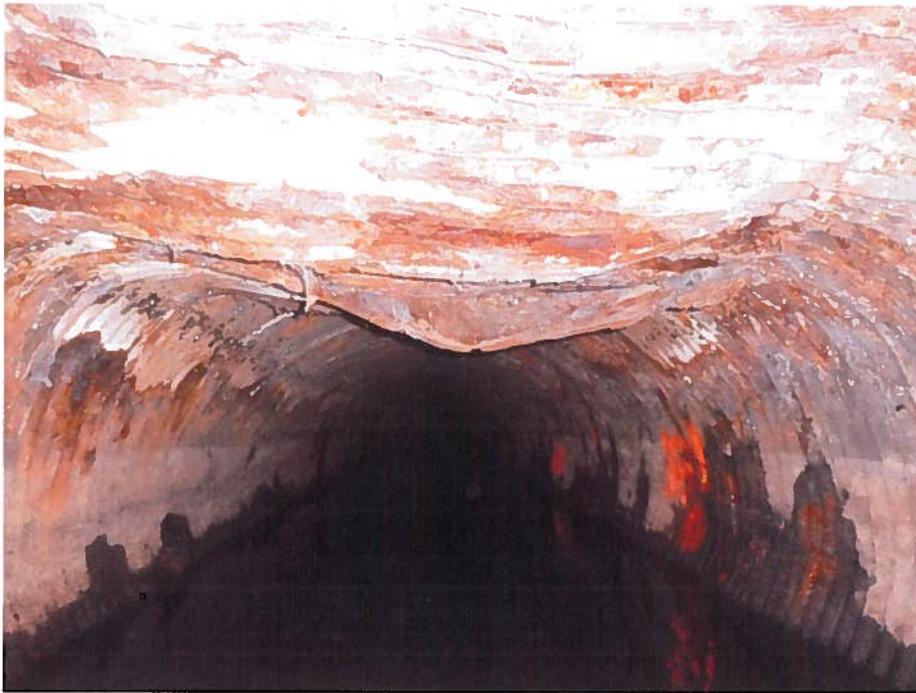
Photo # 3: Sta. 1+25, Collapse of culvert at sanitary sewer location, water infiltration

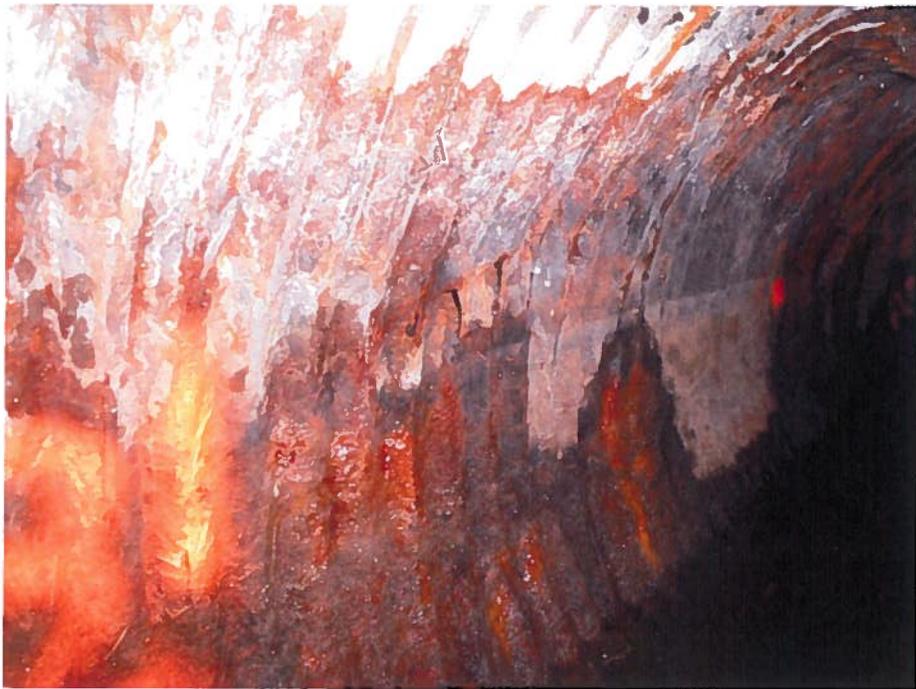
Photo # 4: Sta. 1+30, East wall, 100% section loss, water infiltration, top of culvert displaced inward

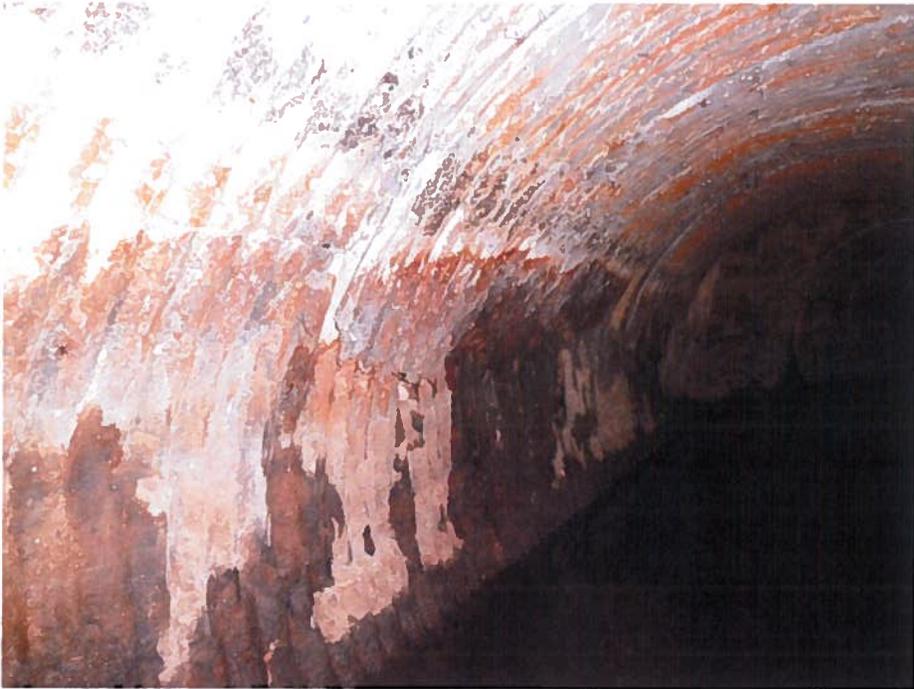
Photo # 5: Sta. 1+60 to sta. 1+70, West wall, 100% section loss, water infiltration

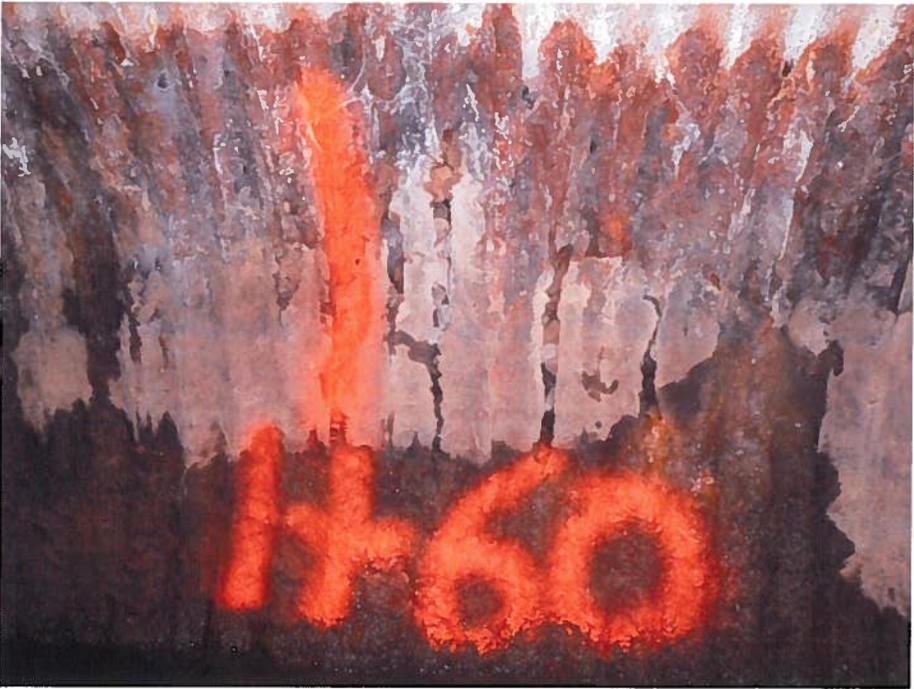
Photo # 6: Sta. 1+60, West wall, 100% section loss, water infiltration

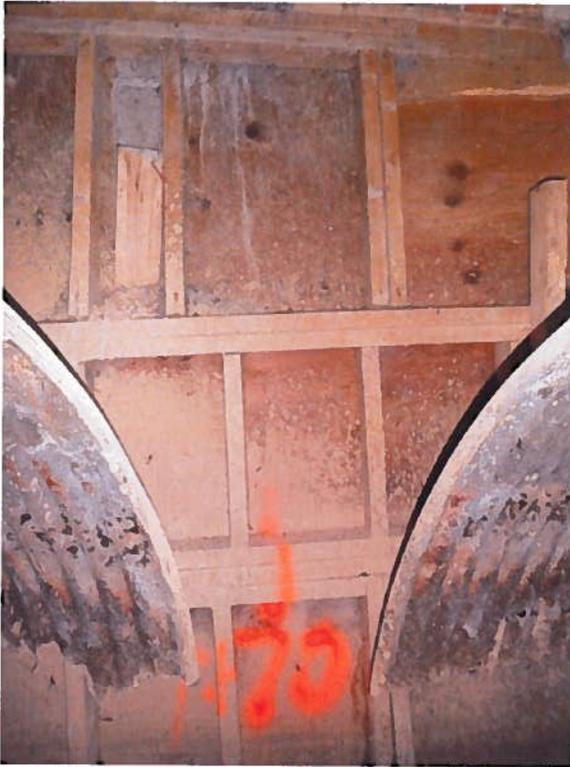
Manhole #2 is located at station 1+70 and provides a change in culvert alignment and connection to the cast-in-place arch section. The manhole is 6'-6" square and is made up of laid brick and cast-in-place walls. It appears that the cast-in-place concrete was a repair to the structure. The wood forming is still in place along the interior of the manhole. The structure has a 9" thick cast-in-place roof slab and a precast concrete riser to grade. A 24" cmp enters the manhole from the southwest and appears to have been plugged 20' from the manhole. This manhole is in poor condition.

Photo # 7: Sta. 1+70, Manhole no. 2, east wall, forming left in place from previous repair

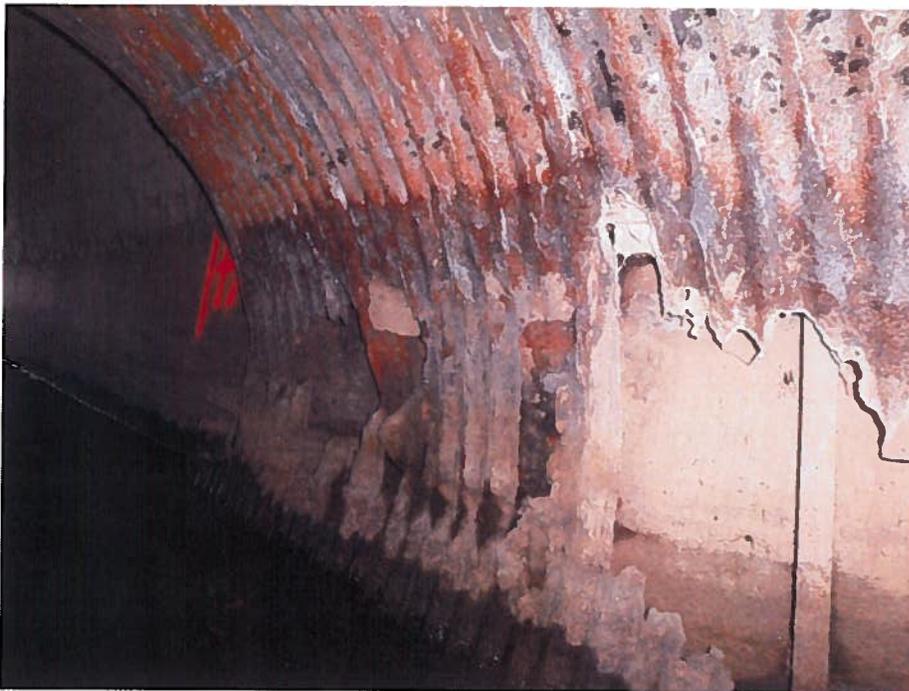
Photo # 8: Sta. 1+70 to sta. 1+77 East wall, transition from manhole no. 2 to C.I.P. arch

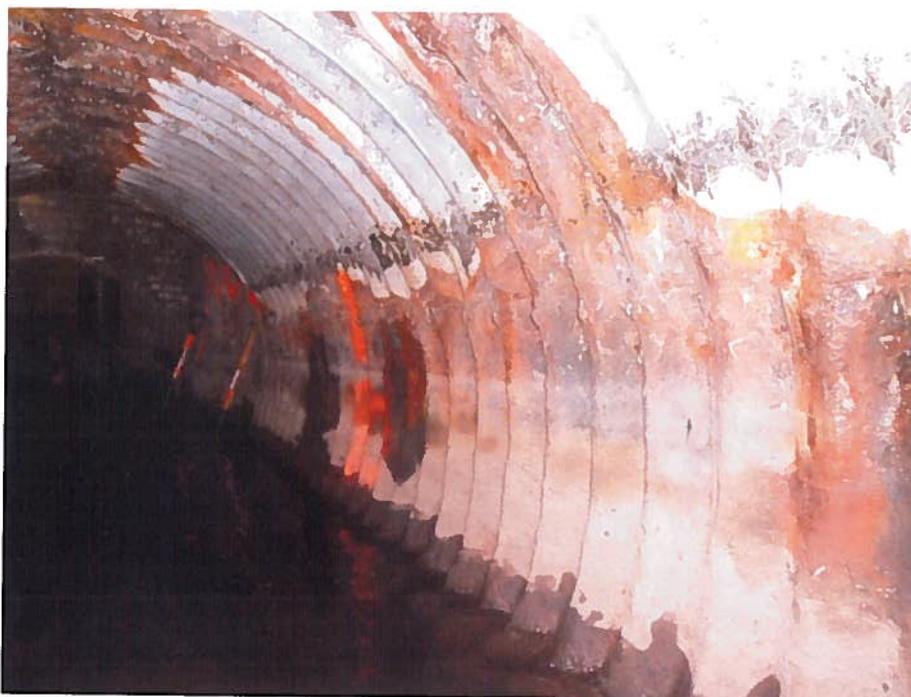
Photo # 9: East wall from sta. 0+85 looking towards manhole no. 1, corrosion, water infiltration

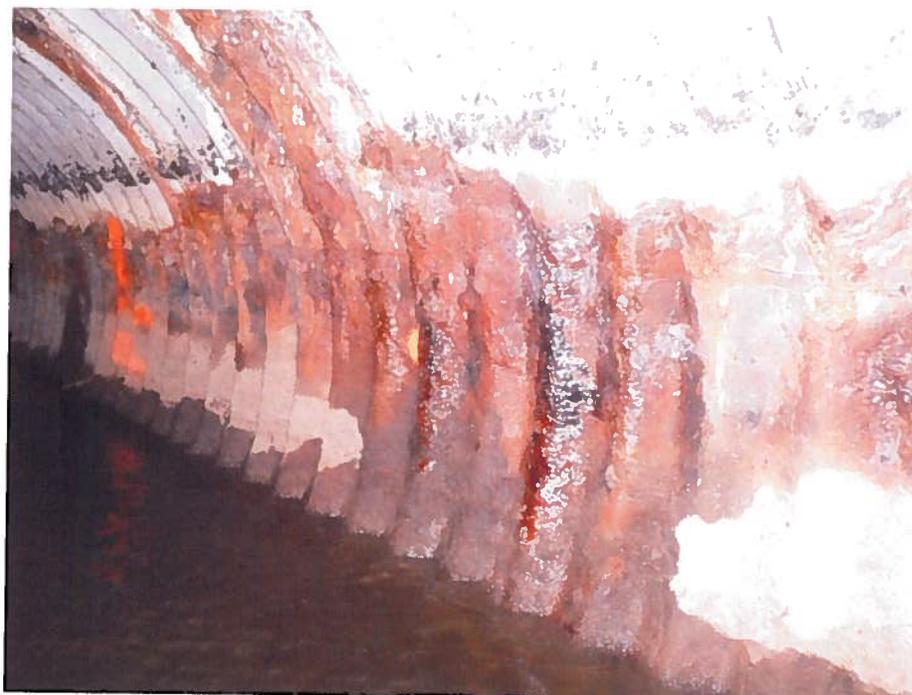
Photo # 10: Sta. 0+55, East wall, water infiltration, corrosion

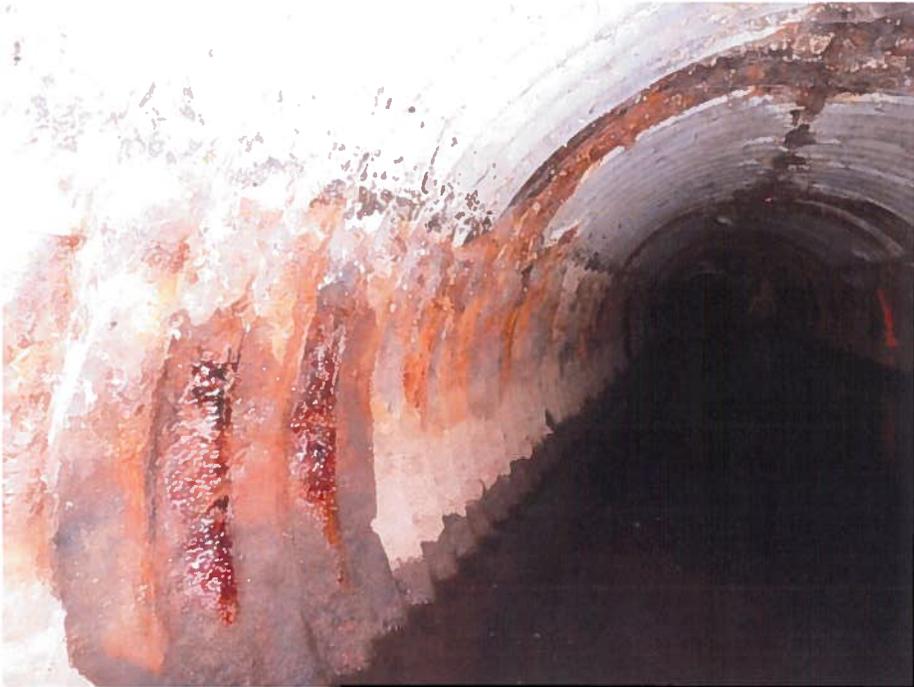
Photo # 11: Sta. 0+55, West wall, water infiltration, corrosion

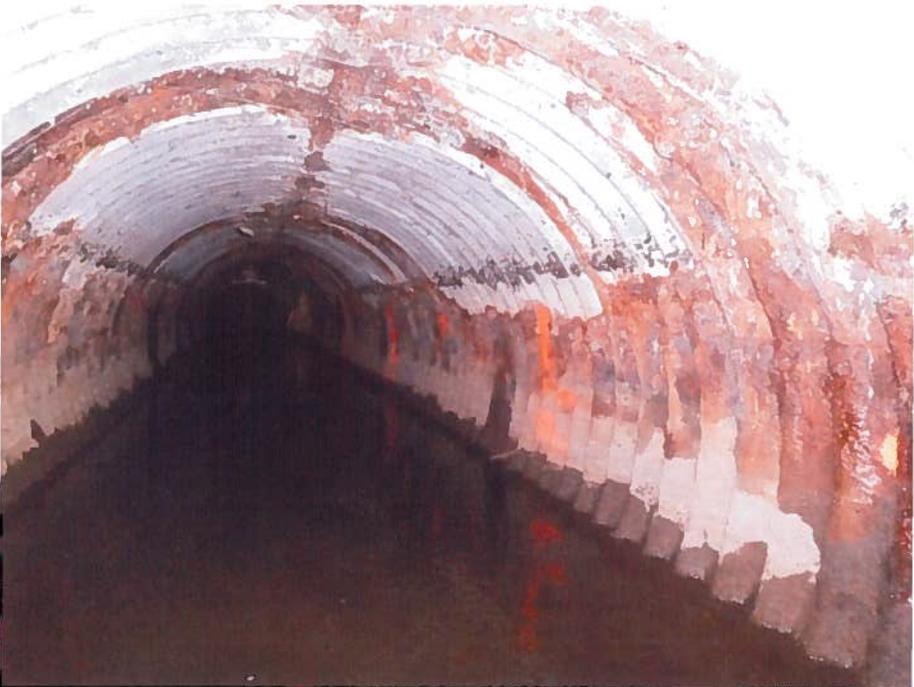
Photo # 12: Sta. 0+55 to sta. 0+65, East wall, water infiltration, corrosion

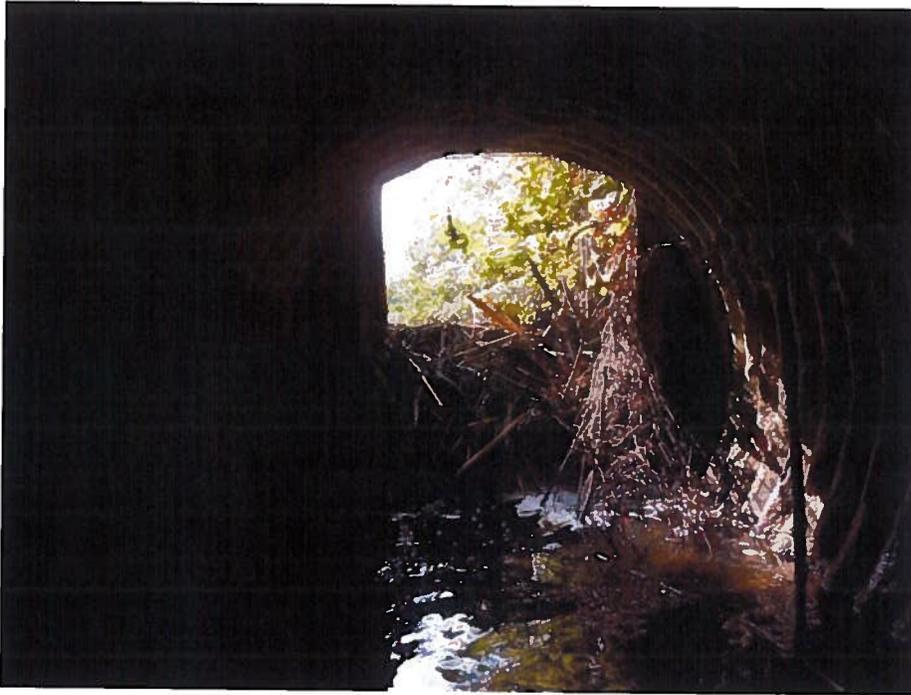
The weir located at the inlet end is covered with debris. The structural concrete supporting the weir structure is deteriorated and spalling. Steel sheet piling provides a headwall across the inlet end. On the west face of the inlet, water is bypassing the weir through a gap between the sheet piling and weir structure.

Photo # 13: Culvert inlet, weir cover by debris

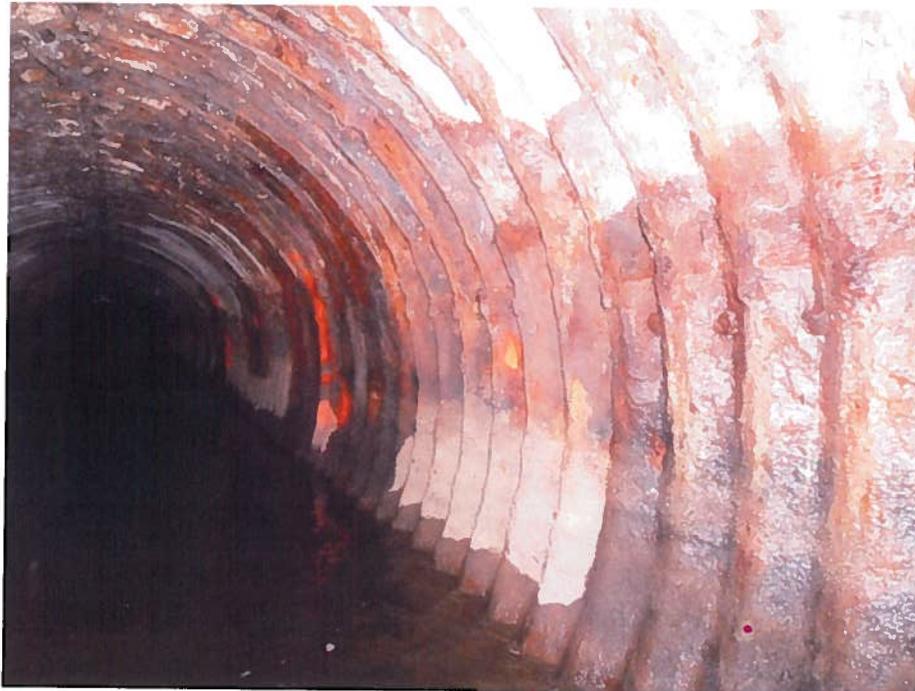
Photo # 14: Sta. 0+10 to sta. 0+20, east wall, water infiltration, corrosion around circumference
