INTERIM REMEDIAL MEASURE REPORT

**14-60 CHARLOTTE STREET
ROCHESTER, NEW YORK**

NYSDEC Spills #0070043 & #0070044

Revised Date: October 2002

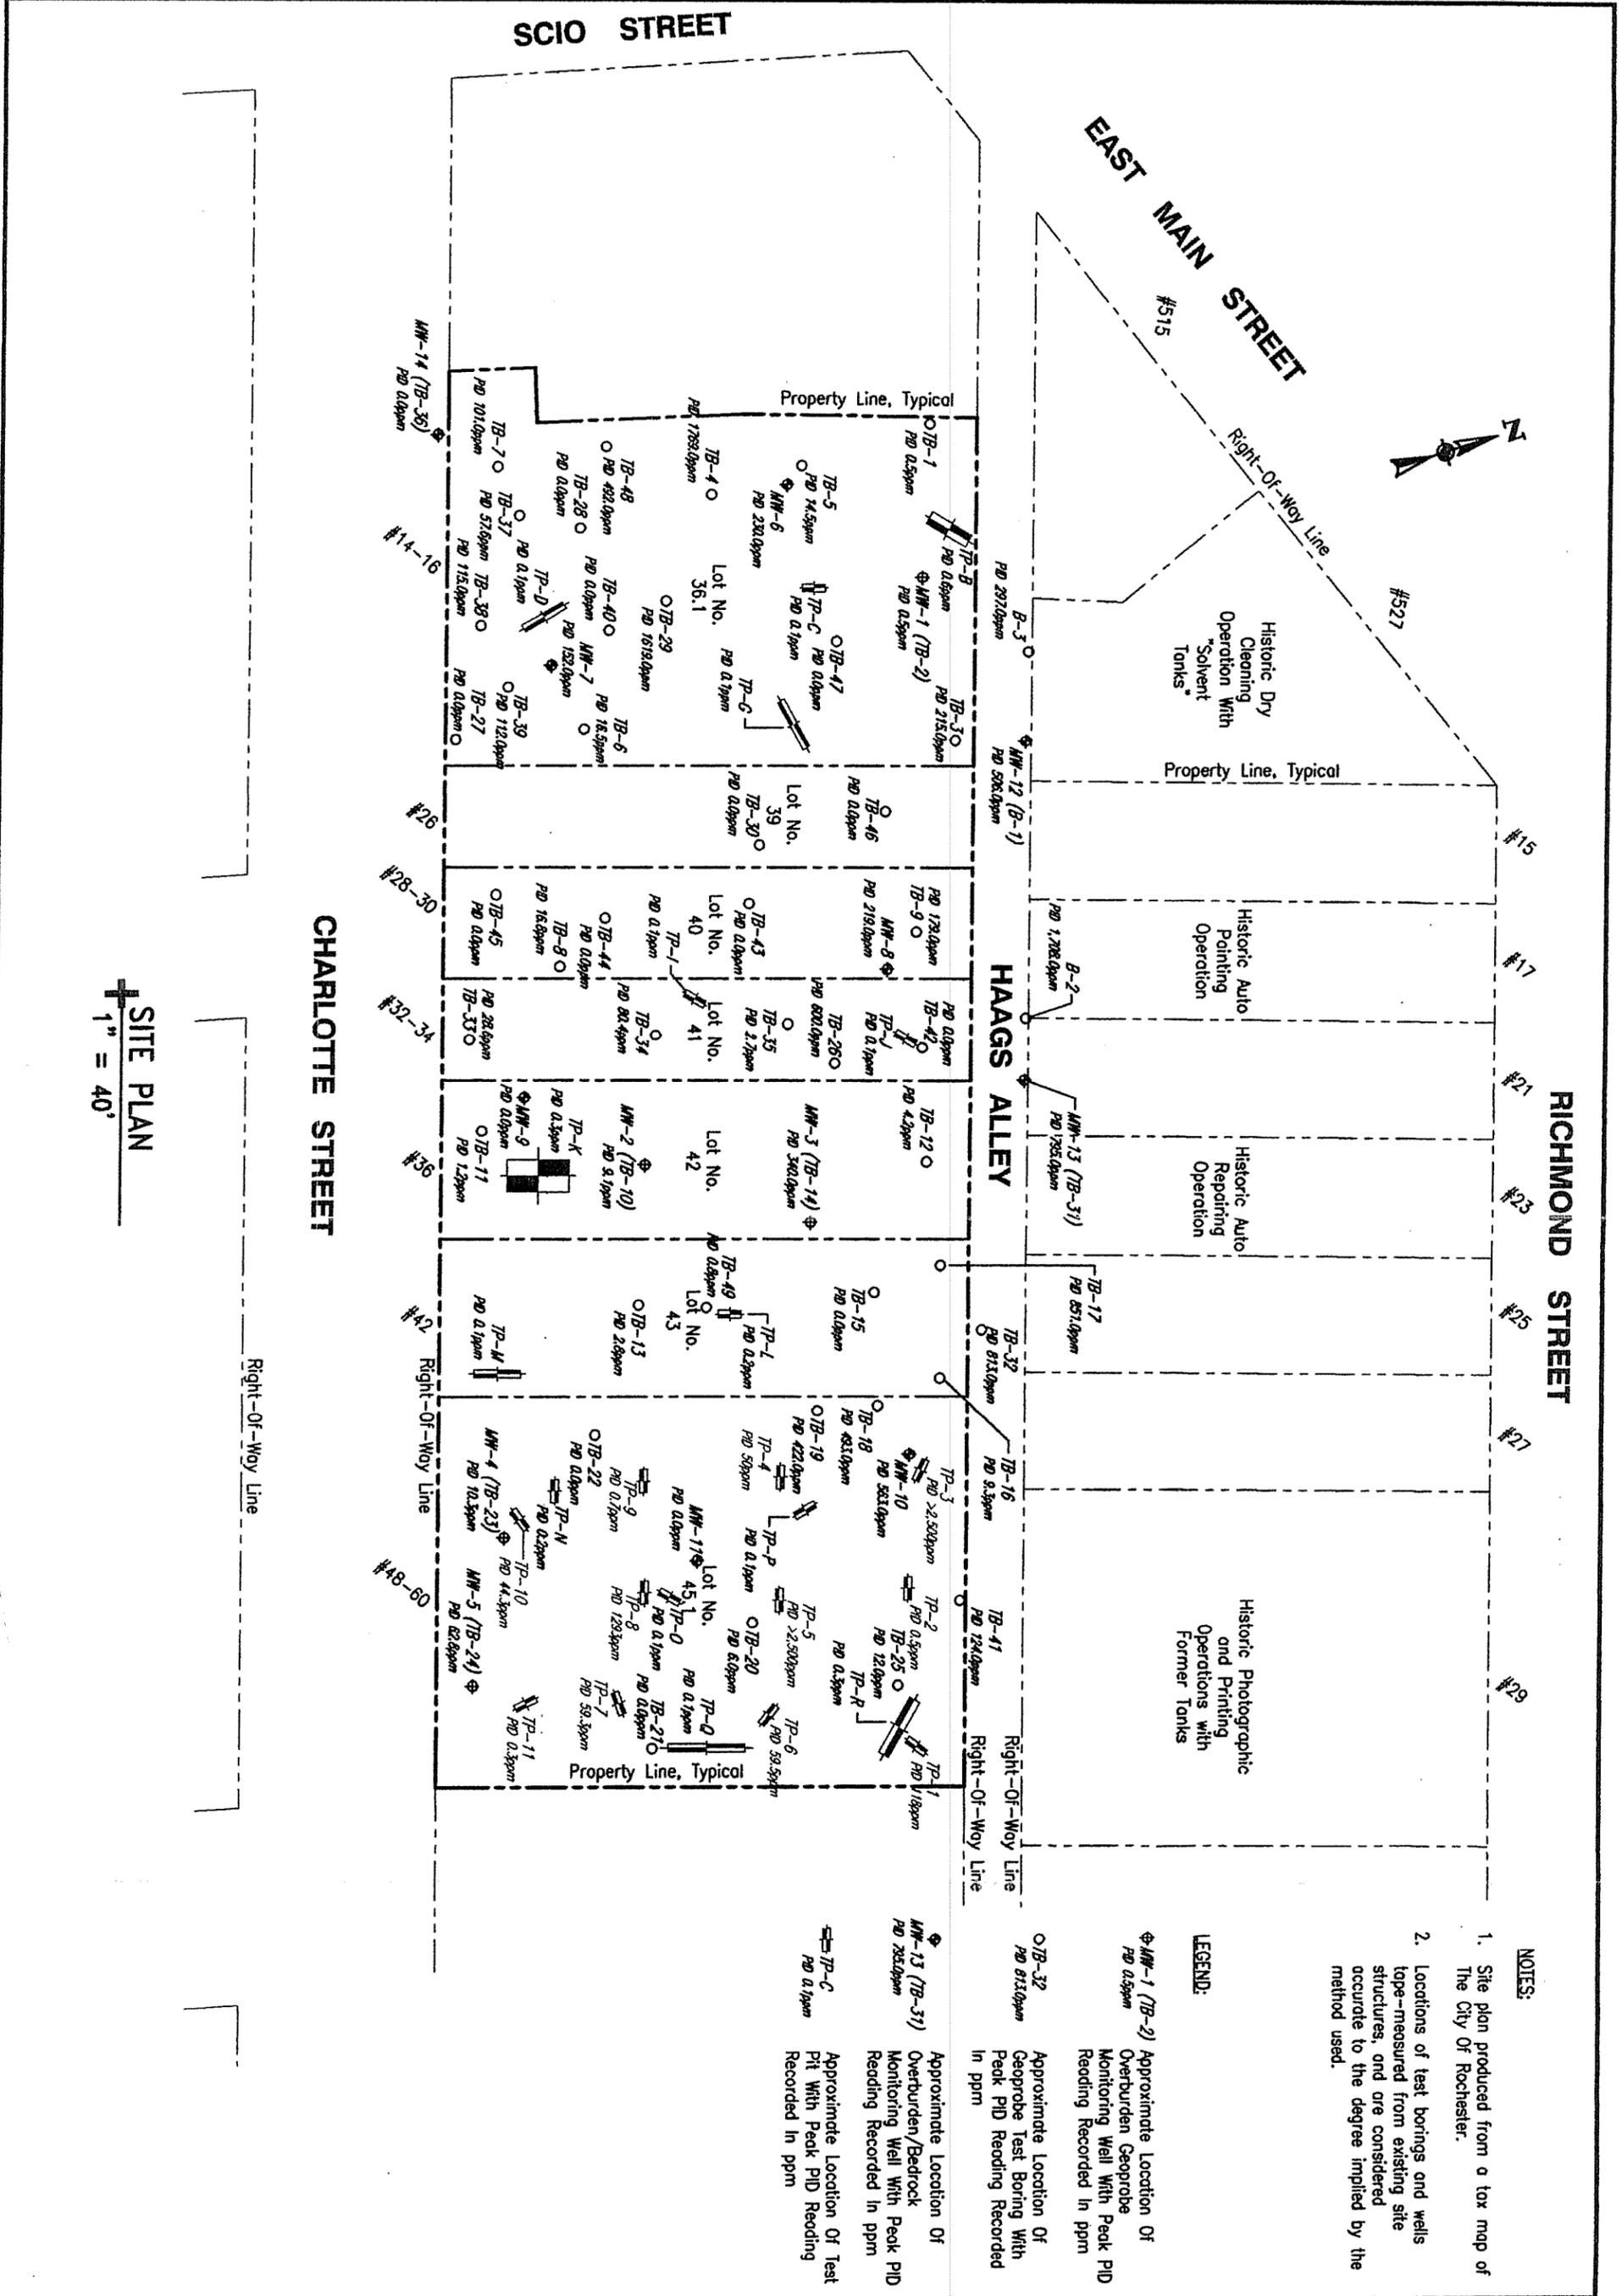
DAY previously completed various environmental studies at the Site and in the right-of-ways of Haags Alley and Charlotte Street (refer to Figure 3 included in Appendix A). These studies are summarized in reports prepared by DAY titled "Supplemental Phase II Environmental Studies, 14-60 Charlotte Street, Rochester, New York" dated November 2000 and "Supplemental Environmental Studies, 14-60 Charlotte Street, Rochester, New York" dated February 2001. These reports identified and documented the existence of soil and groundwater contamination at the Site and in the right-of-way of Haags Alley north of the Site. In addition, light non-aqueous phase liquid (LNAPL) designated as diesel fuel was detected in monitoring well MW-7 located on the southeast portion of the 14-16 Charlotte Street parcel. Some contaminants detected (e.g., light-weight total petroleum hydrocarbon (TPH) identified as mineral spirits and chlorinated volatile organic compounds) appear attributable to an off-site source located north of Haags Alley. Properties that could be considered as potential off-site sources of contamination (e.g., historic dry cleaning operations, historic auto painting operations, etc.) are depicted on Figure 3 included in Appendix A.

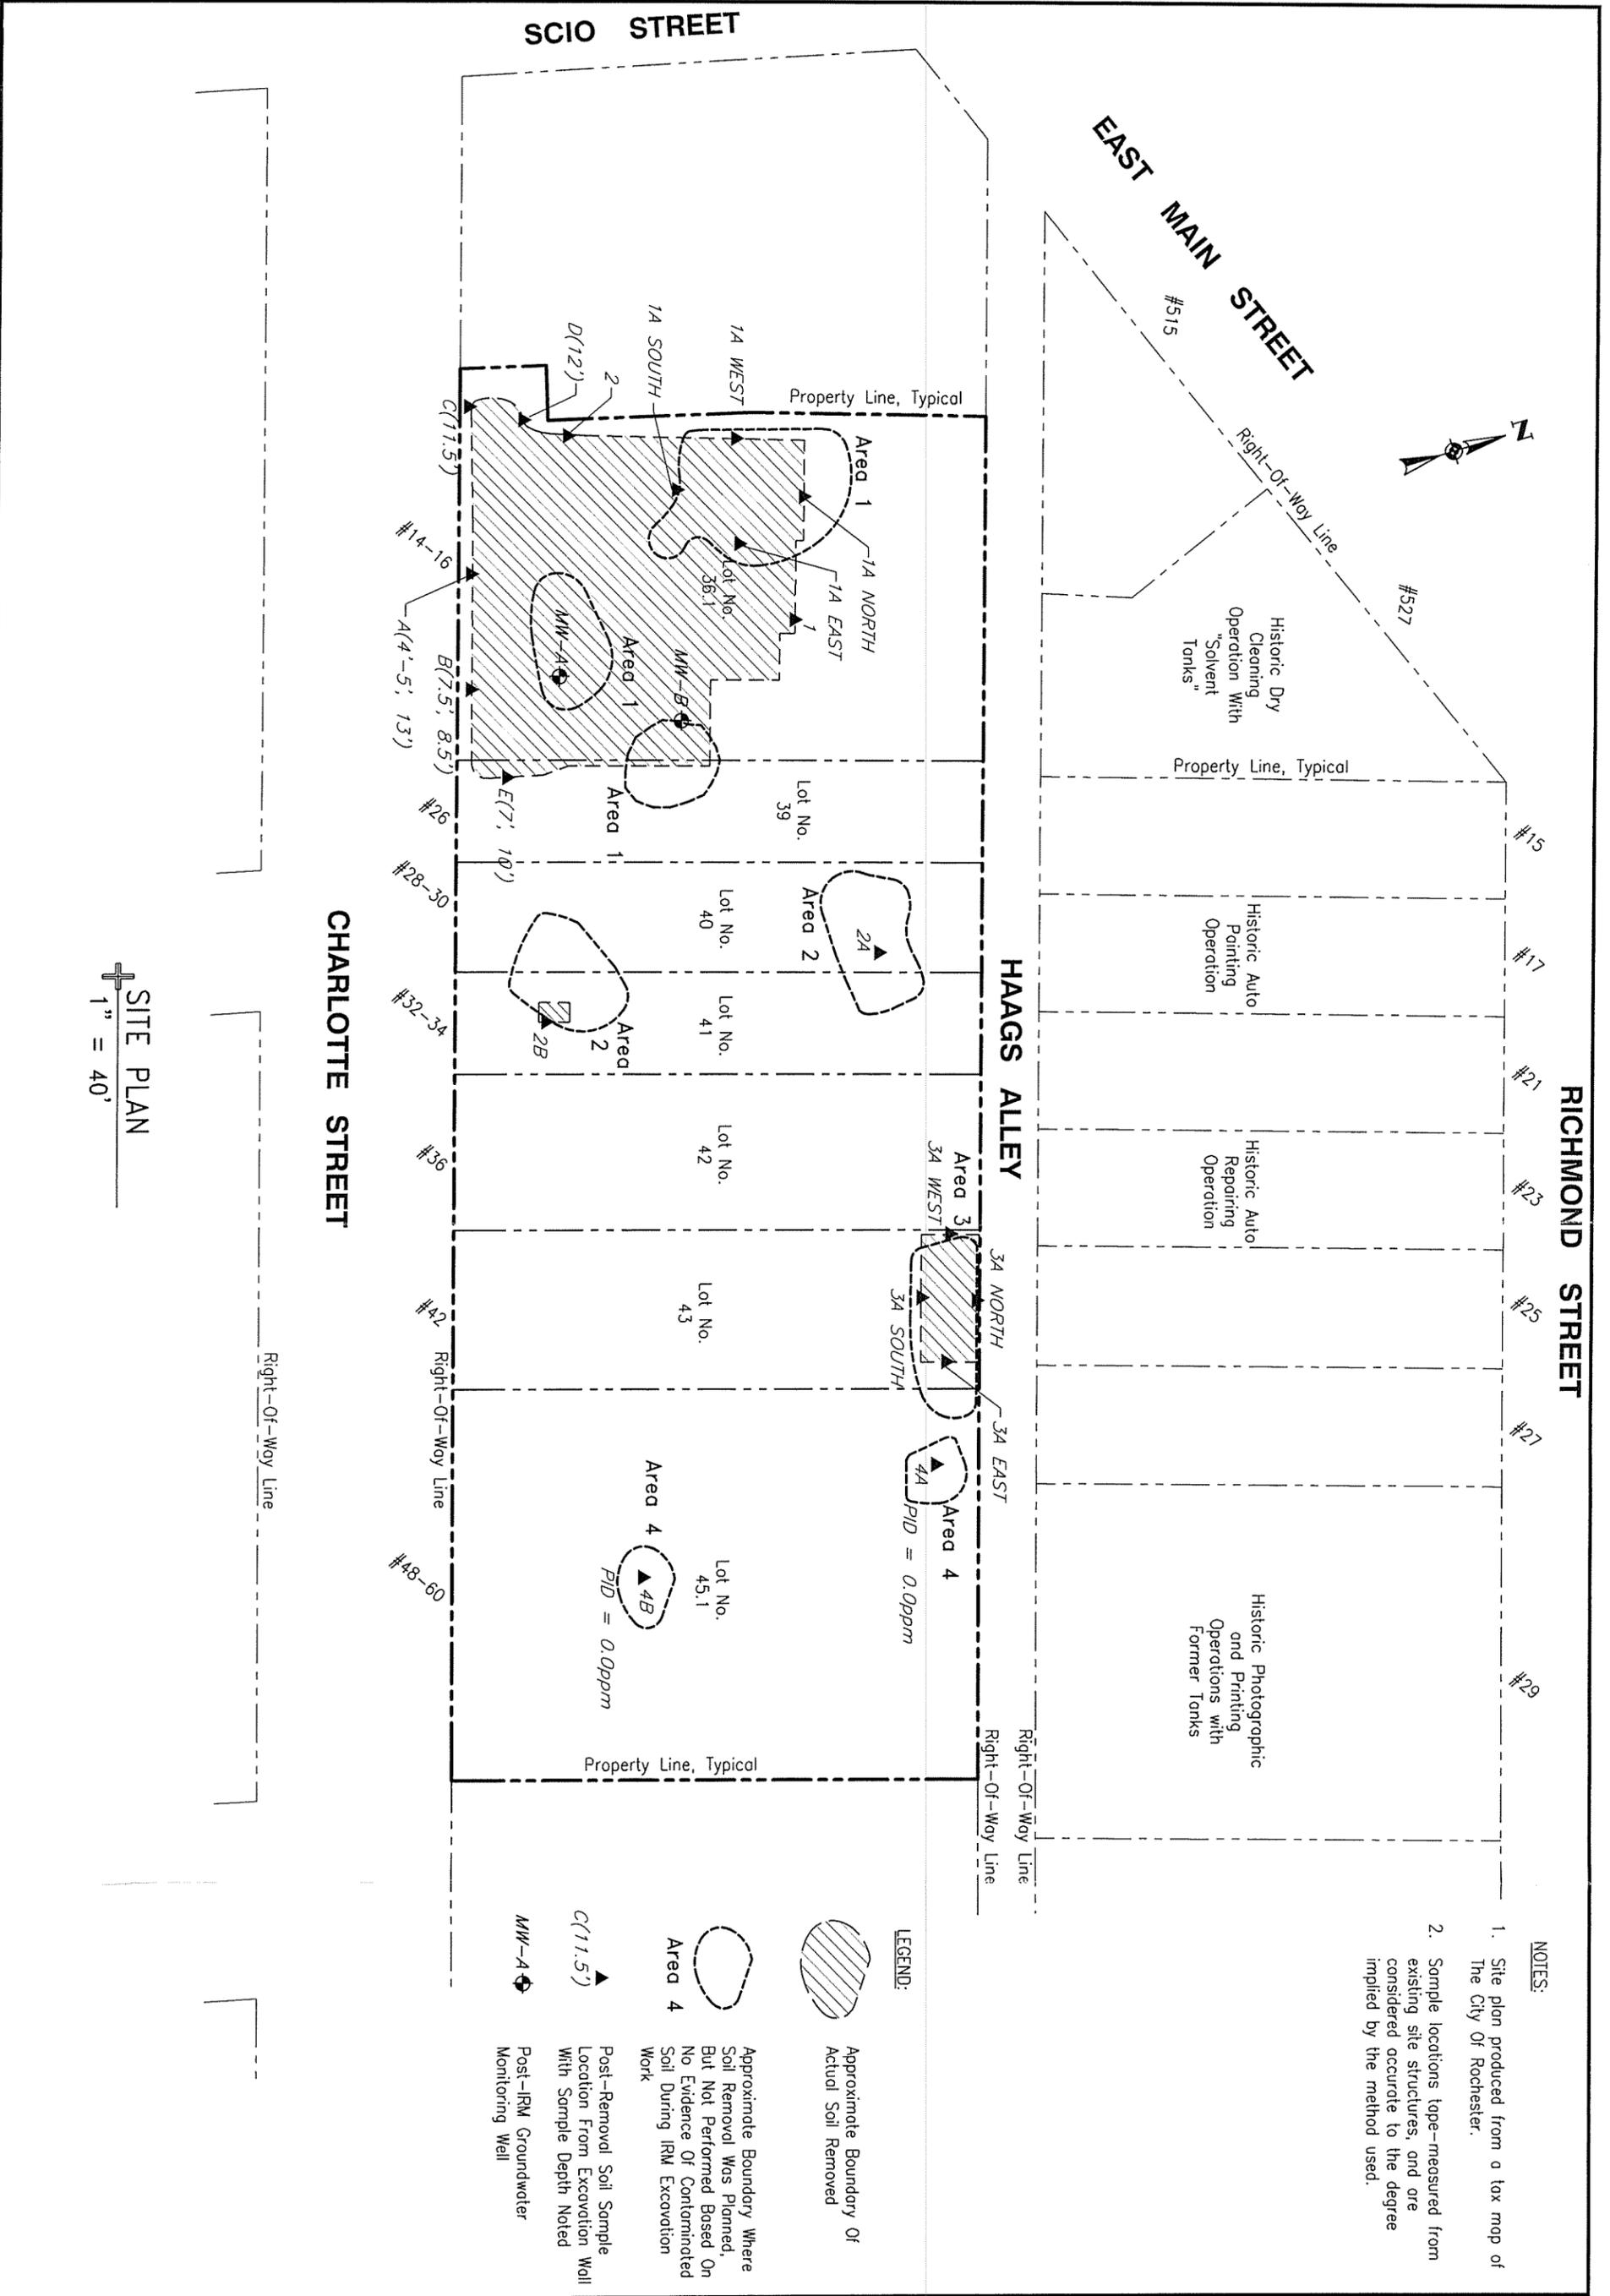
FIGURE 4

Areas of soil contamination were removed to the top of bedrock; however, in some instances, the excavation was generally discontinued when a layer of contaminated soil above bedrock was observed to be less than one foot thick. In most cases, the contamination was at or near the top of bedrock, and a layer of uncontaminated fill and soil ranging between approximately six and ten feet thick required removal to expose the contaminated soil. The uncontaminated fill and soil were staged in piles adjoining the excavation from which it originated, and were later used as backfill in the same excavation. Figure 4 included in Appendix A depicts the anticipated IRM soil removal areas in relation to the actual IRM soil removal areas. As shown on Figure 4,

PROJECT TITLE	14 - 60 CHARLOTTE STREET ROCHESTER, NY
DRAWING TITLE	INTERIM REMEDIAL MEASURE Site Plan Depicting Soil Removal Work and Post-Removal Soil Sample Locations
PROJECT NO.	2485R-00

Only the detected concentrations of one or more specific VOCs and/or the total VOCs in Sample A(13') from Area 1, and Sample B(8.5') from Area 1 exceeded their respective TAGM 4046 recommended soil cleanup objectives (refer to Figures 4 and 5 included in Appendix A).

The concentration of the SVOC naphthalene detected in Sample B (8.5') from Area 1 exceeded its respective TAGM 4046 recommended soil cleanup objective (refer to Figures 4 and 5 included in Appendix A).

- Prior to backfilling, a total of 23 confirmatory soil samples were collected from the walls of IRM excavations and analyzed for TCL and STARS-list VOCs using USEPA Method 8260, STARS-list SVOCs using USEPA Method 8270, and for TPH using NYSDOH Method 310.13. Based on the analytical laboratory test results, only two soil samples (i.e., Samples A @ 13' and B @ 8.5') collected from the south excavation wall along the southern property line of the 14-16 Charlotte Street parcel contained specific VOCs and/or SVOCs at concentrations above TAGM 4046 recommended soil cleanup objectives, [i.e., the location where the Charlotte Street right-of-way inhibited further removal of contaminated soil above bedrock (refer to Figures 4 and 5 included in Appendix A)].

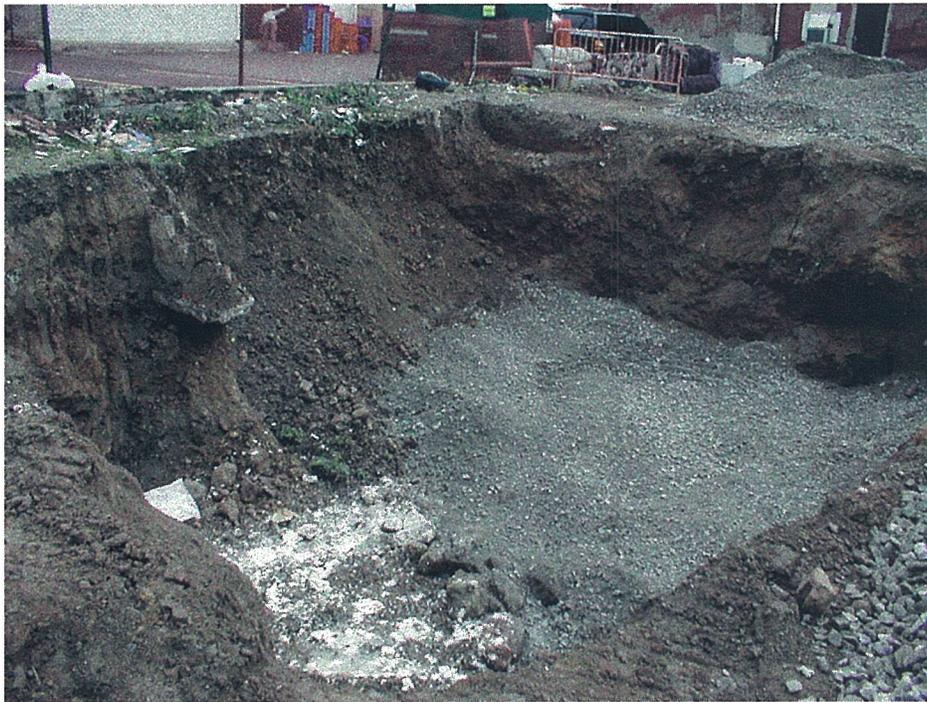
November 2001 - Placement of ORC and backfilling bottom of excavation with crusher run fill – West portion of Area 1 on 14-16 Charlotte Street Parcel

- ORC was placed at the bottom of excavations on the 14-16 Charlotte Street parcel to enhance biodegradation of residual petroleum contamination in the saturated zone.

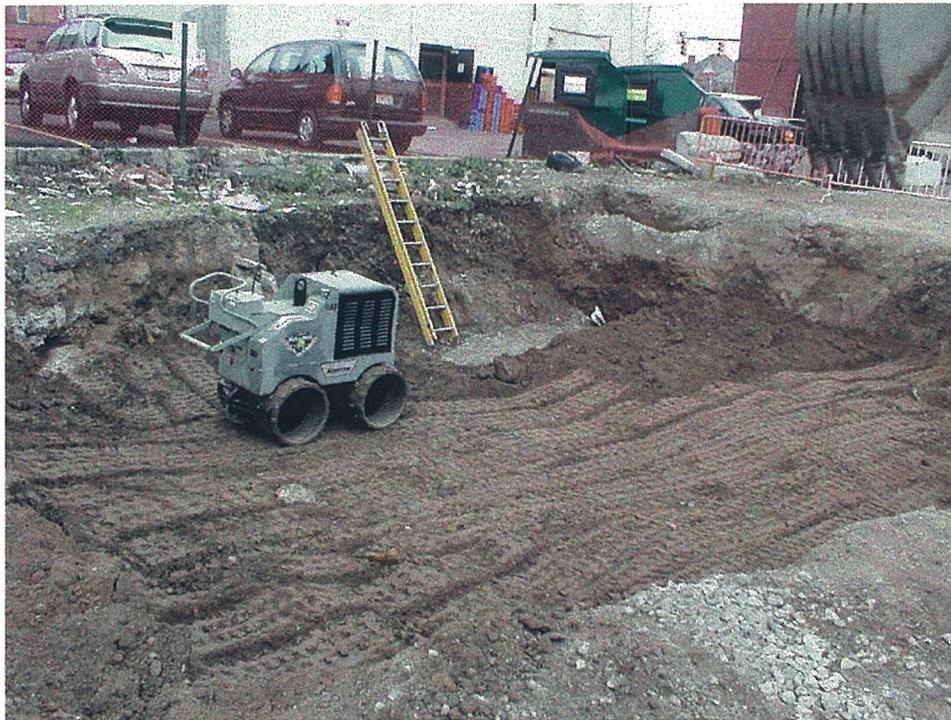
November 2001 - Placement of clean fill sourced on-site into excavation - West portion of Area 1 on 14-16 Charlotte Street Parcel

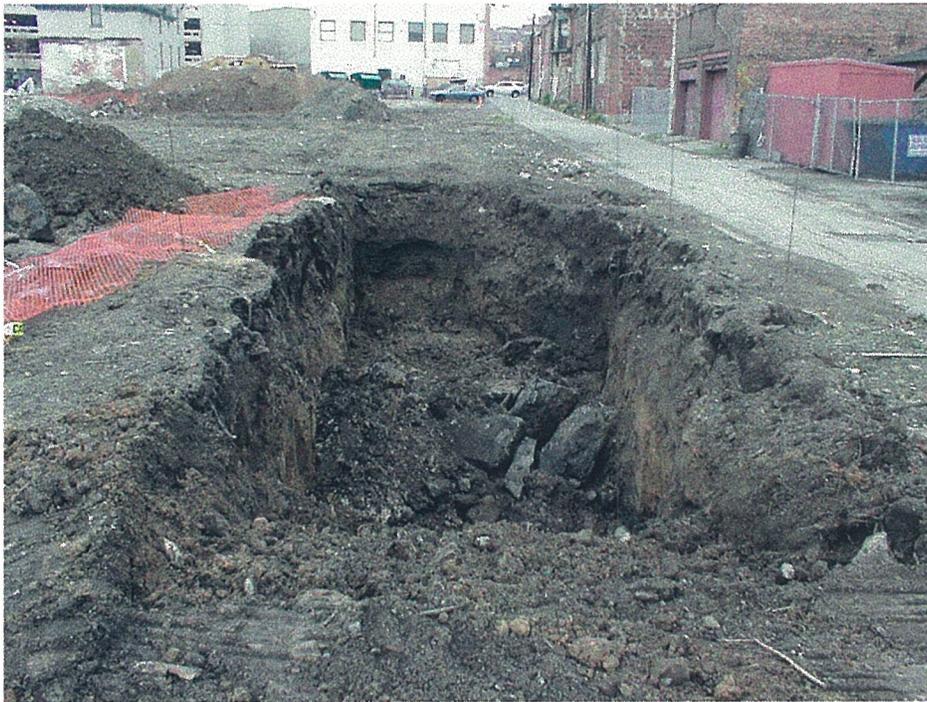
November 2001 - Soil excavation - Area 3 on 42 Charlotte Street Parcel

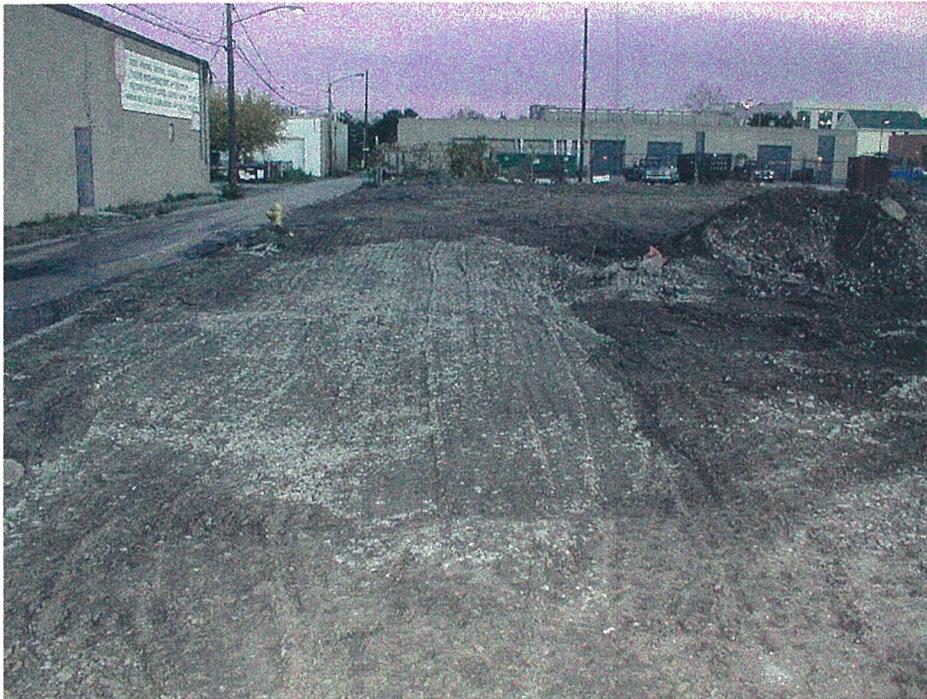
November 2001 - Minimum one-foot thick layer of crusher run fill placed and compacted at top of excavation - Area 3 on 42 Charlotte Street Parcel

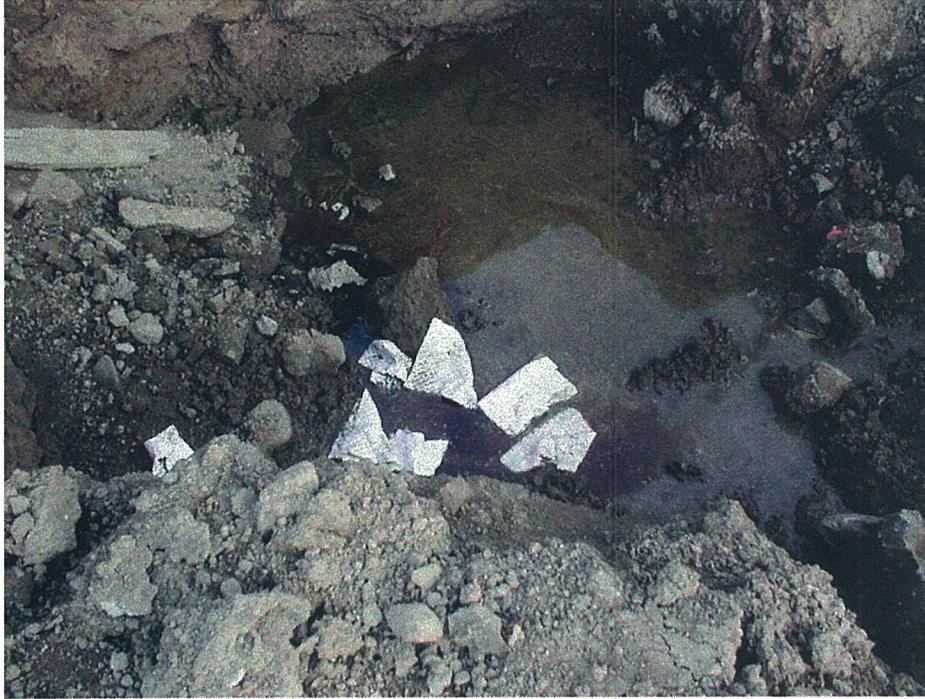
November 2001 - Placement of absorbent pads on area of LNAPL – Southern portion of Area 1 on 14-16 Charlotte Street Parcel.

It was anticipated that LNAPL (diesel fuel or heating oil) might be encountered on the southern portion of Area 1 and require removal. However, during soil removal work in this area, only a few small approximate four-foot diameter or less areas of LNAPL (0.1 inch thick or less) were observed floating on the top of groundwater in the excavation. These areas were removed using absorbent pads and disposed off-site with the contaminated soil.

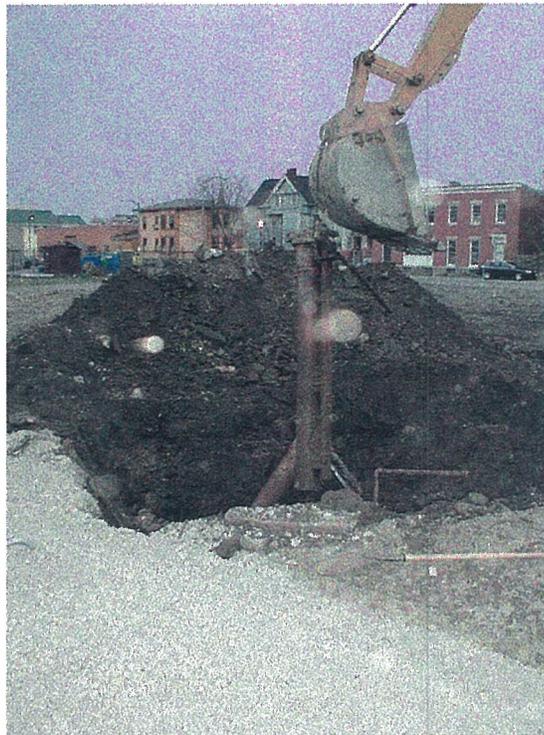
November 2001 – Removal of in-ground hydraulic lift - Area 3 on 42 Charlotte Street Parcel

On November 19, 2001, Arrow removed one in-ground two-cylinder hydraulic lift with a reservoir tank and associated hardware from the 42 Charlotte Street parcel. The reservoir tank and one post were empty, and approximately one quart of hydraulic oil was removed from the other post and placed in a 5-gallon container. Arrow subsequently transported and disposed of the lift and the hydraulic oil off-site.

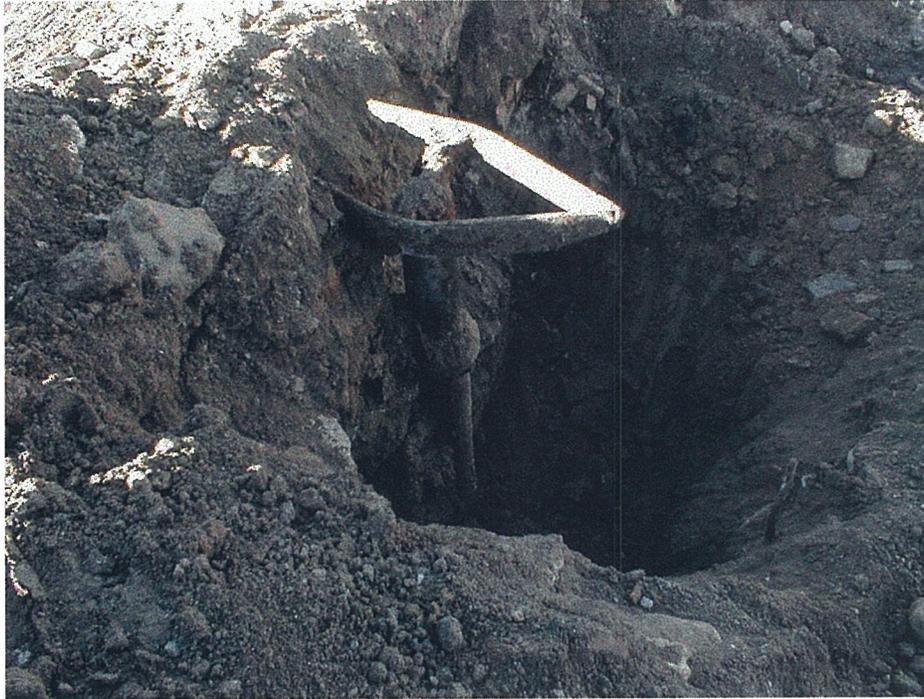
November 2001 – In-ground lift cylinder– Area 1 on 14-16 Charlotte Street parcel

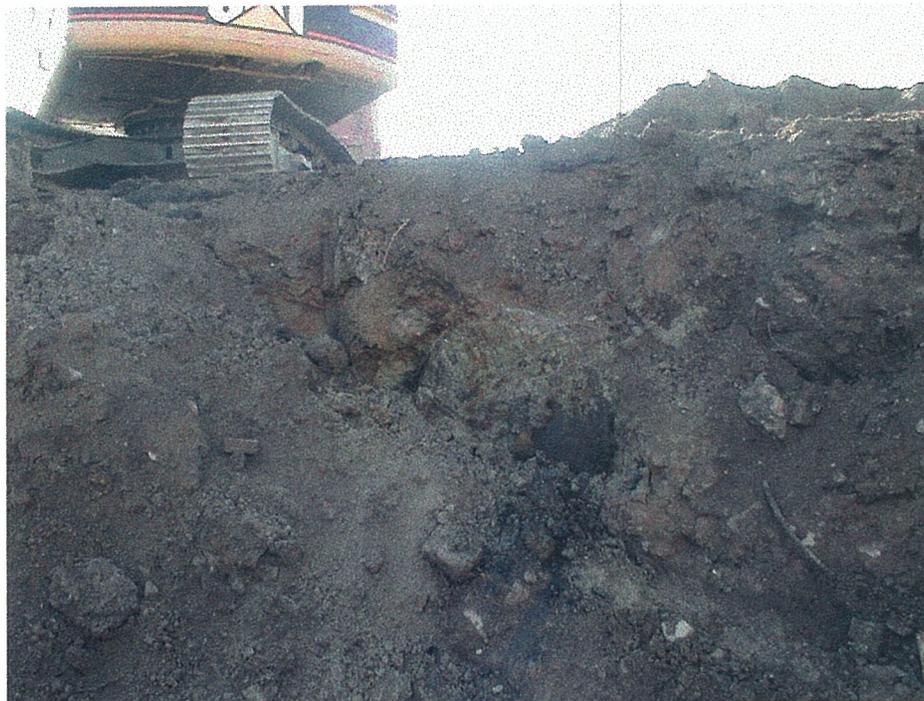
November 2001 – Underground storage tank encountered - Area 1 on 14-16 Charlotte Street Parcel

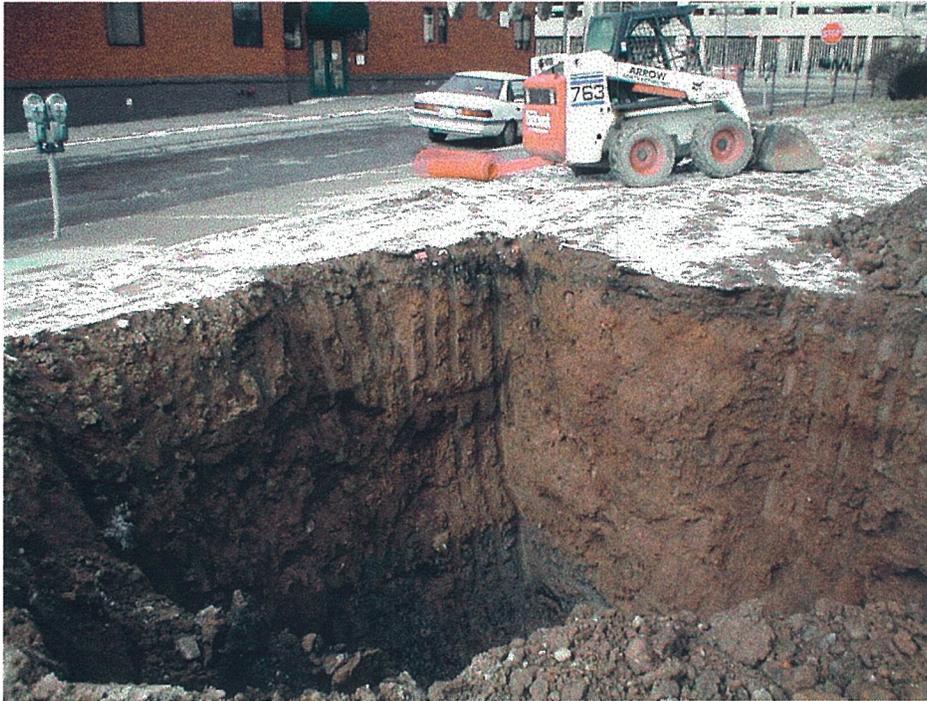
March 2002 – Soil removal – South portion of Area 1 on 14-16 Charlotte Street parcel

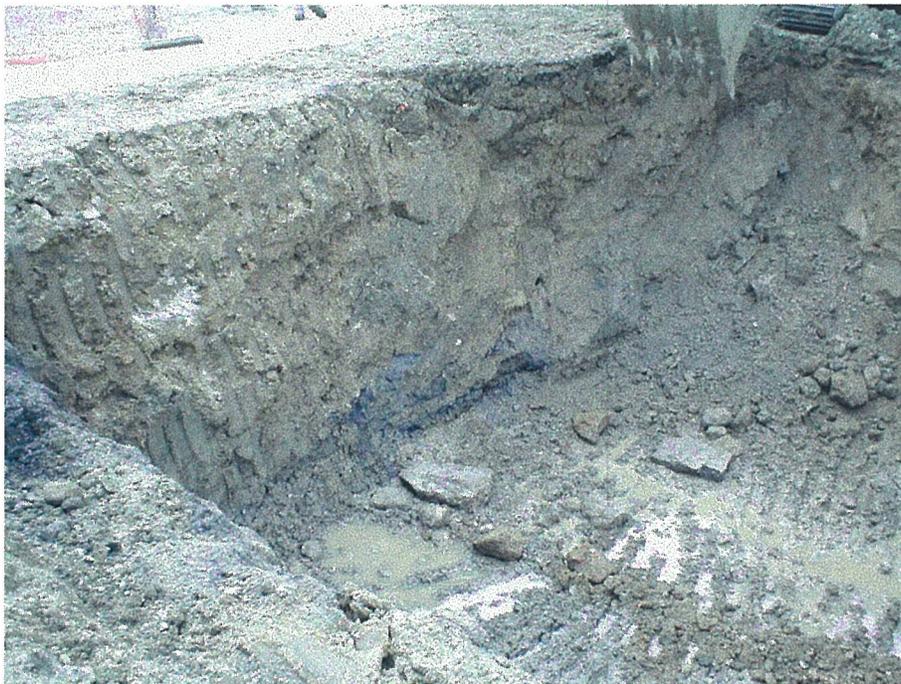
March 2002 – Contaminated soil along Charlotte Street that was left in-place in side wall at bottom of excavation – Southern portion of Area 1 on 14-16 Charlotte Street parcel

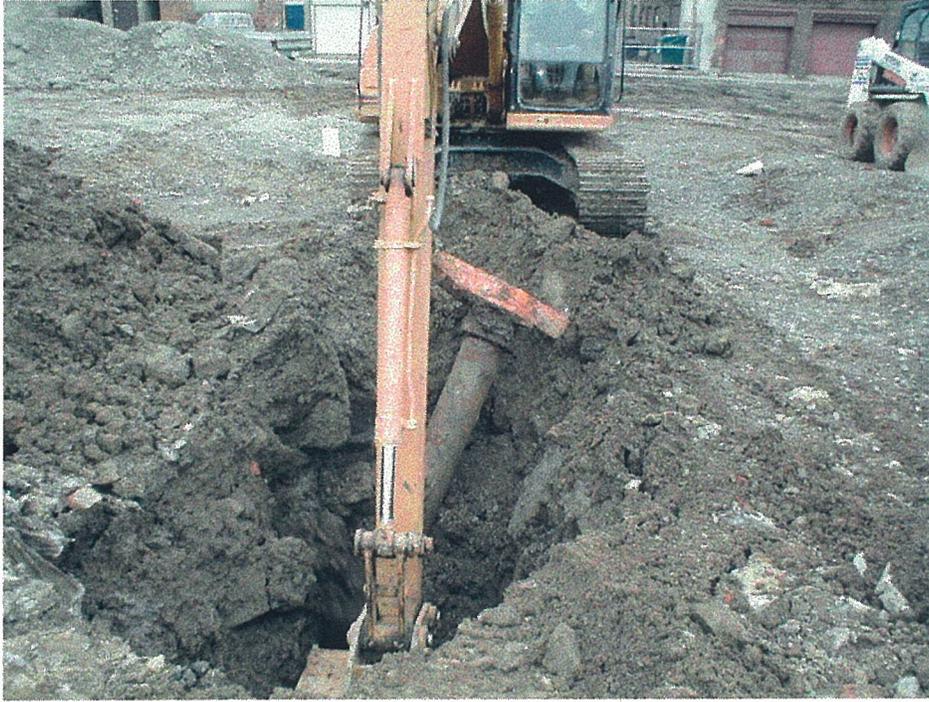
March 2002 – Removal of in-ground lift cylinder – Southeast portion of Area 1 on 14-16 Charlotte Street parcel

On March 25, 2002, Arrow removed one lift cylinder from a former in-ground hydraulic lift from the 14-16 Charlotte Street parcel. Approximately five gallons of hydraulic oil were removed from the lift cylinder and placed in a 5-gallon container. Arrow subsequently transported and disposed of this lift and the hydraulic oil off-site.

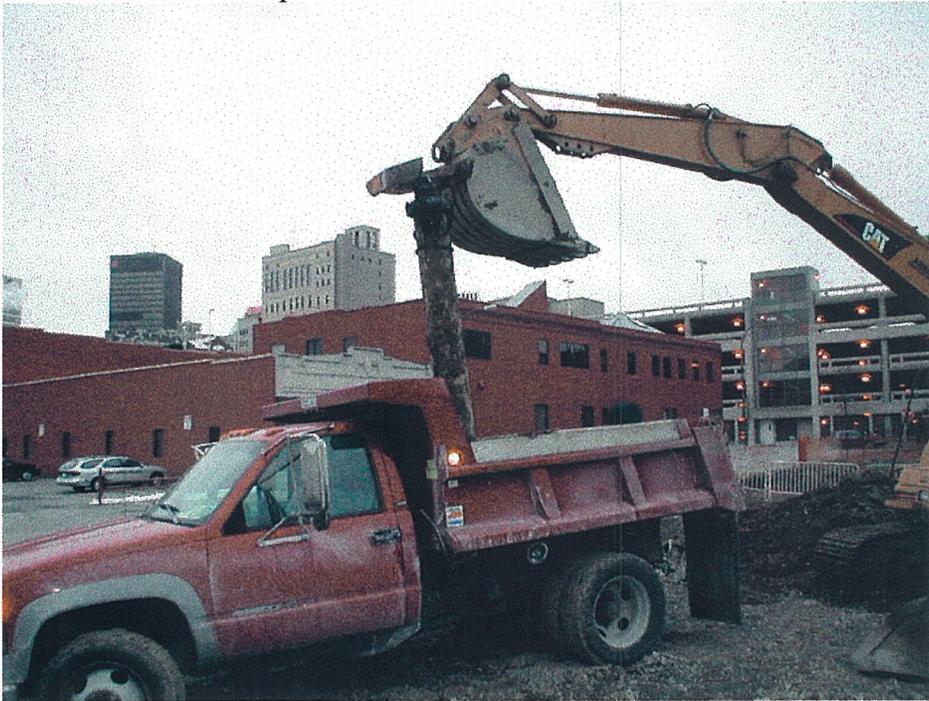
March 2002 – Loading in-ground lift cylinder for of-site disposal – Area 1 on 14-16 Charlotte Street parcel

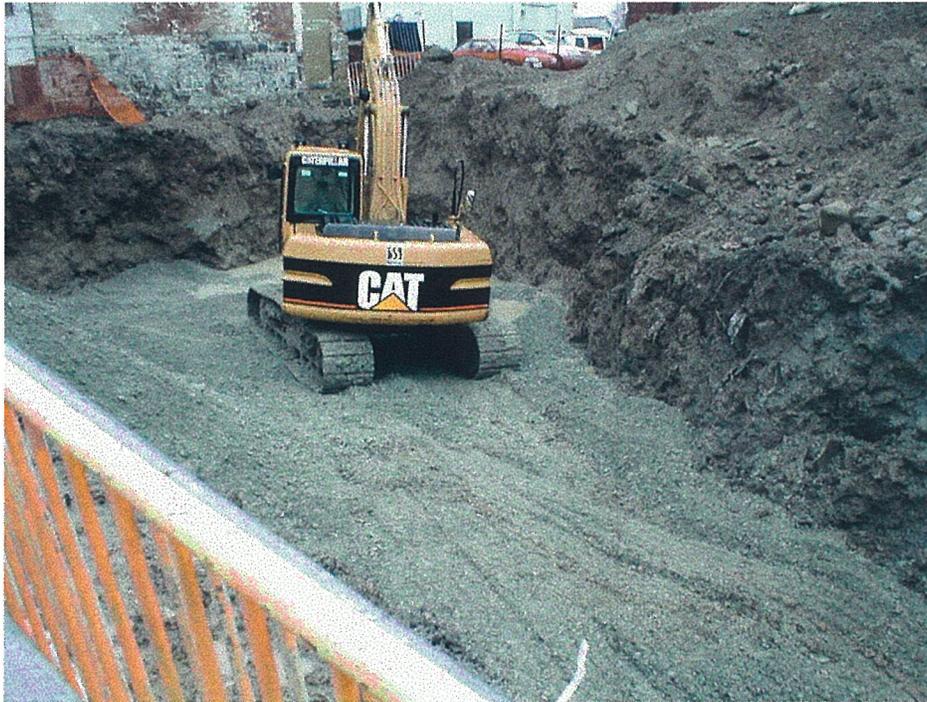
March 2002 – Placing crusher run fill at bottom of excavation – South portion of Area 1 on 14-16 Charlotte Street parcel

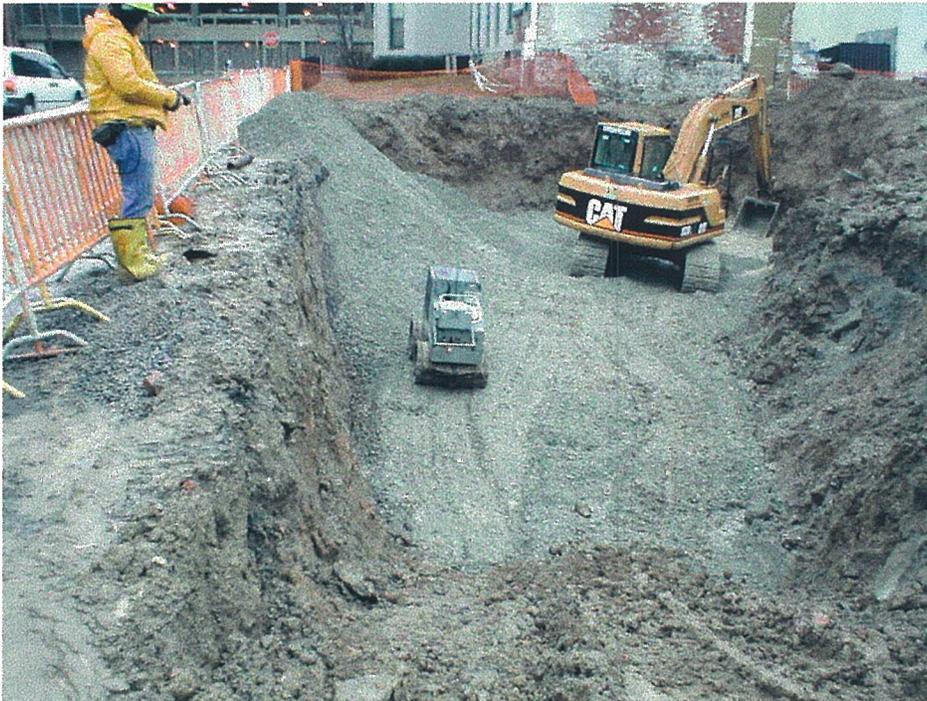
March 2002 – Placing and compacting crusher run fill at bottom of excavation – South portion of Area 1 on 14-16 Charlotte Street parcel

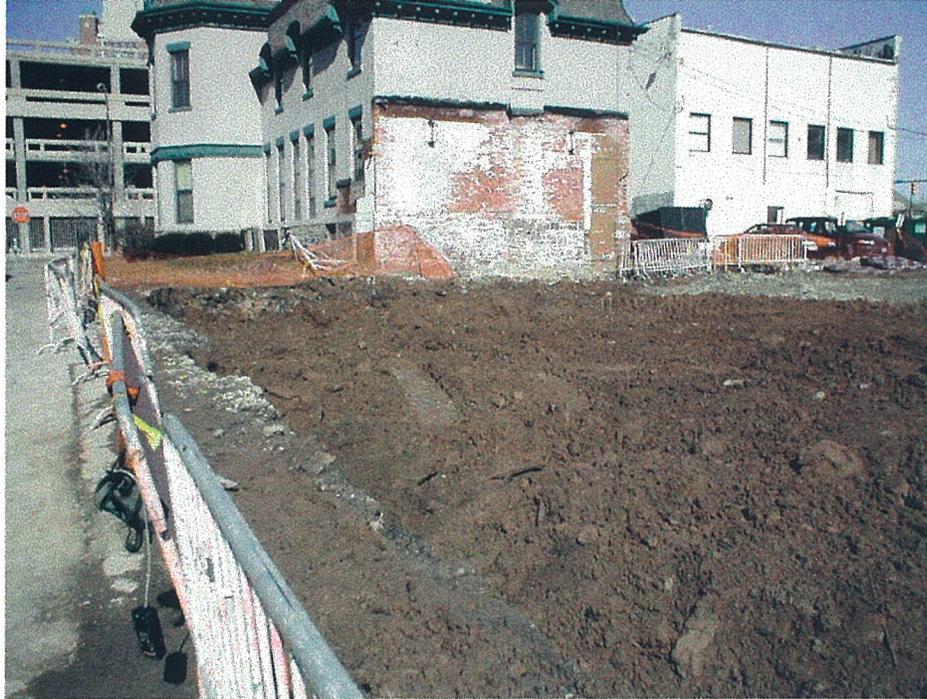
March 2002 – Excavation backfilled with on-site soil/fill – South portion of Area 1 on 14-16 Charlotte Street parcel

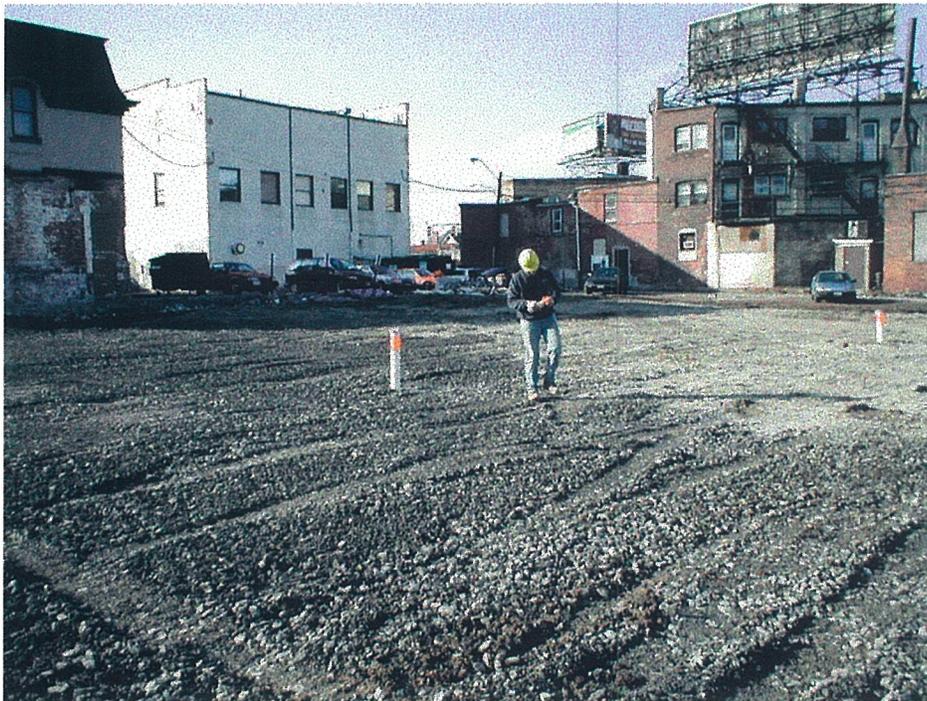
March 2002 – Minimum one-foot thick layer of crusher run fill placed and compacted at top of excavation, also shows new wells MW-A and MW-B – Area 1 on 14-16 Charlotte Street parcel

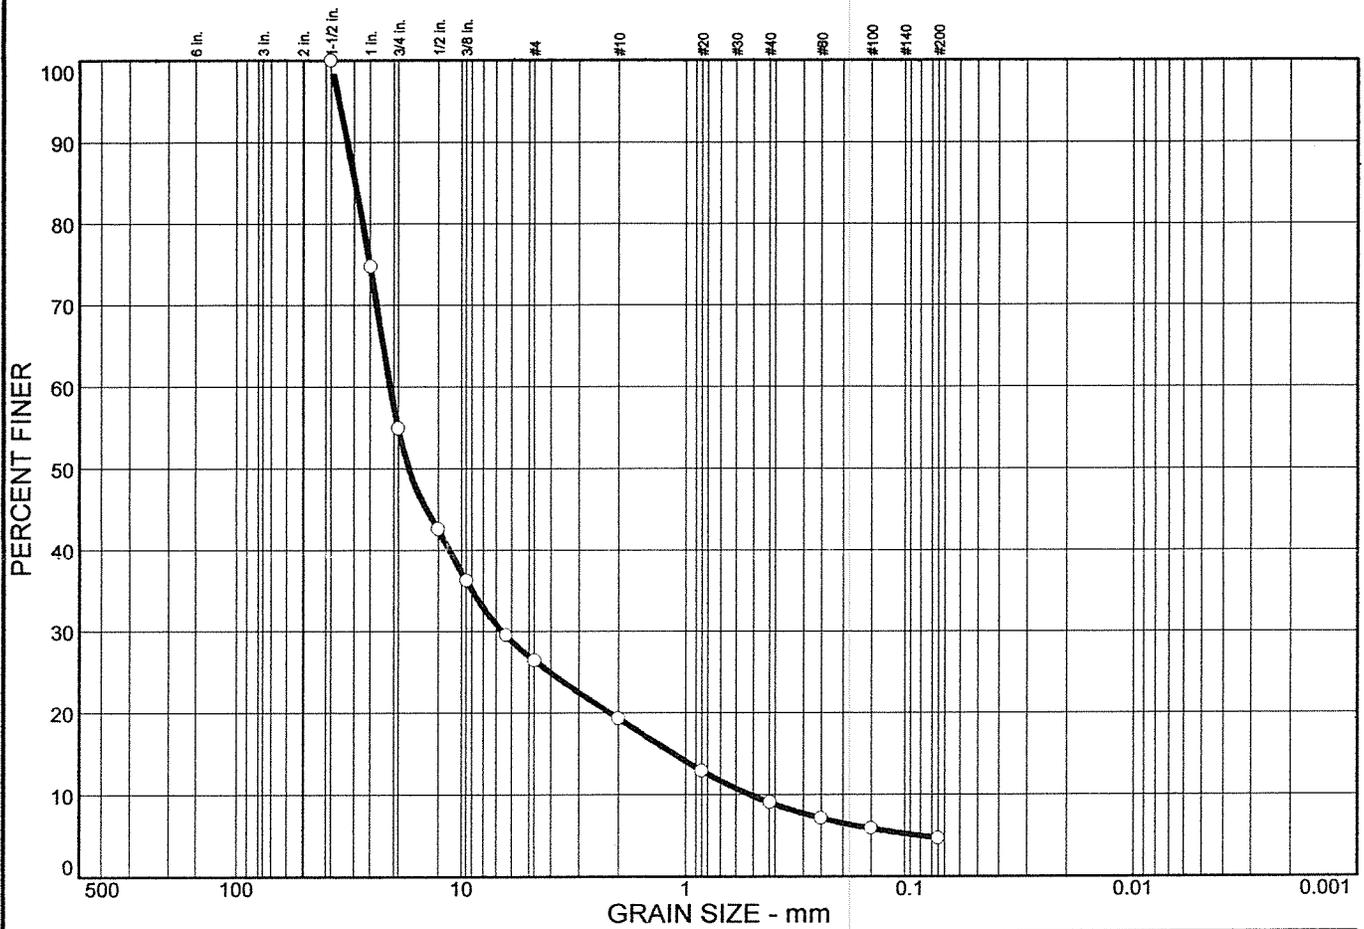
Particle Size Distribution Report

% COBBLES	% GRAVEL	% SAND	% SILT	% CLAY
0.0	73.5	21.8	4.7	0.0

SIEVE SIZE	PERCENT FINER	SPEC.* PERCENT	PASS? (X=NO)
1.5 in.	100.0		
1 in.	74.8		
.75 in.	55.0		
.5 in.	42.6		
.375 in.	36.3		
.25 in.	29.6		
#4	26.5		
#10	19.4		
#20	13.0		
#40	9.1		
#60	7.2		
#100	5.9		
#200	4.7

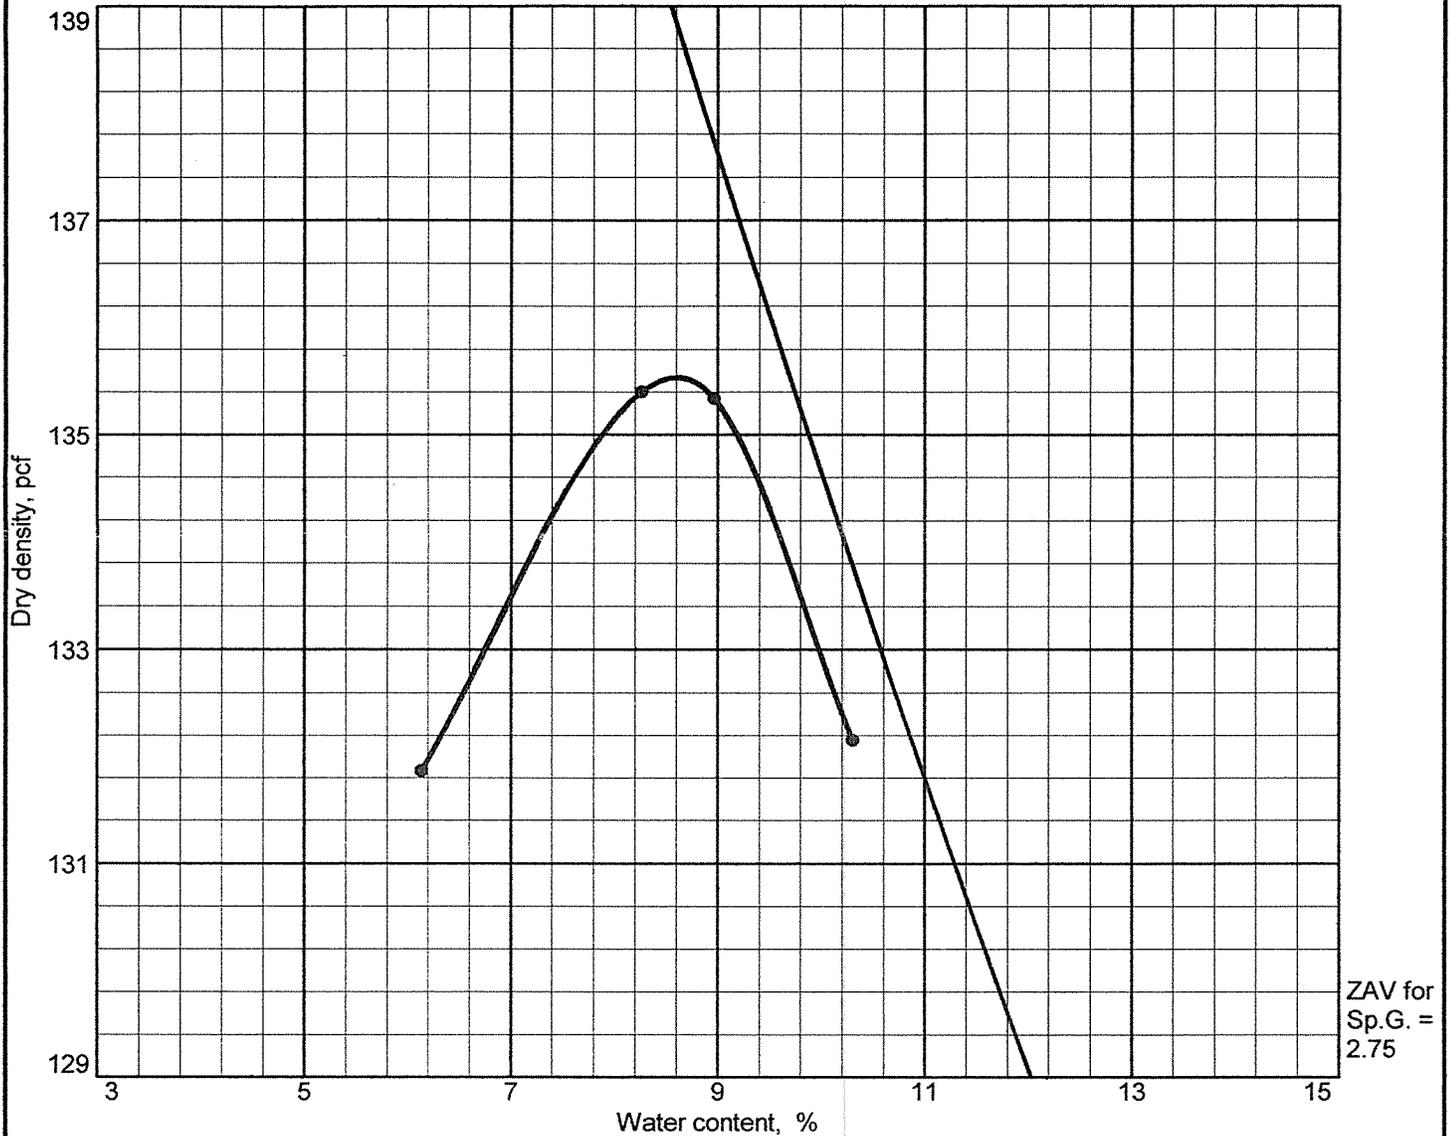
Test specification: ASTM D 1557-91 Procedure C Modified

TEST RESULTS	MATERIAL DESCRIPTION
Maximum dry density = 136 pcf Optimum moisture = 9 %	#2 Crusher Run Stone
Project No. RCH-01-394 Client: Day Environmental Project: Charlotte Street ● Source: On-site Material Sample No.: 01-1580	Remarks: Sample picked up by VanDerHorst on 11-15-01
COMPACTION TEST REPORT <h2 style="margin: 0;">VAN DER HORST ENGINEERING</h2>	
Figure Number 01-1580
