INTERIM REMEDIAL MEASURE REPORT

**14-60 CHARLOTTE STREET
ROCHESTER, NEW YORK**

NYSDEC Spills #0070043 & #0070044

Revised Date: October 2002

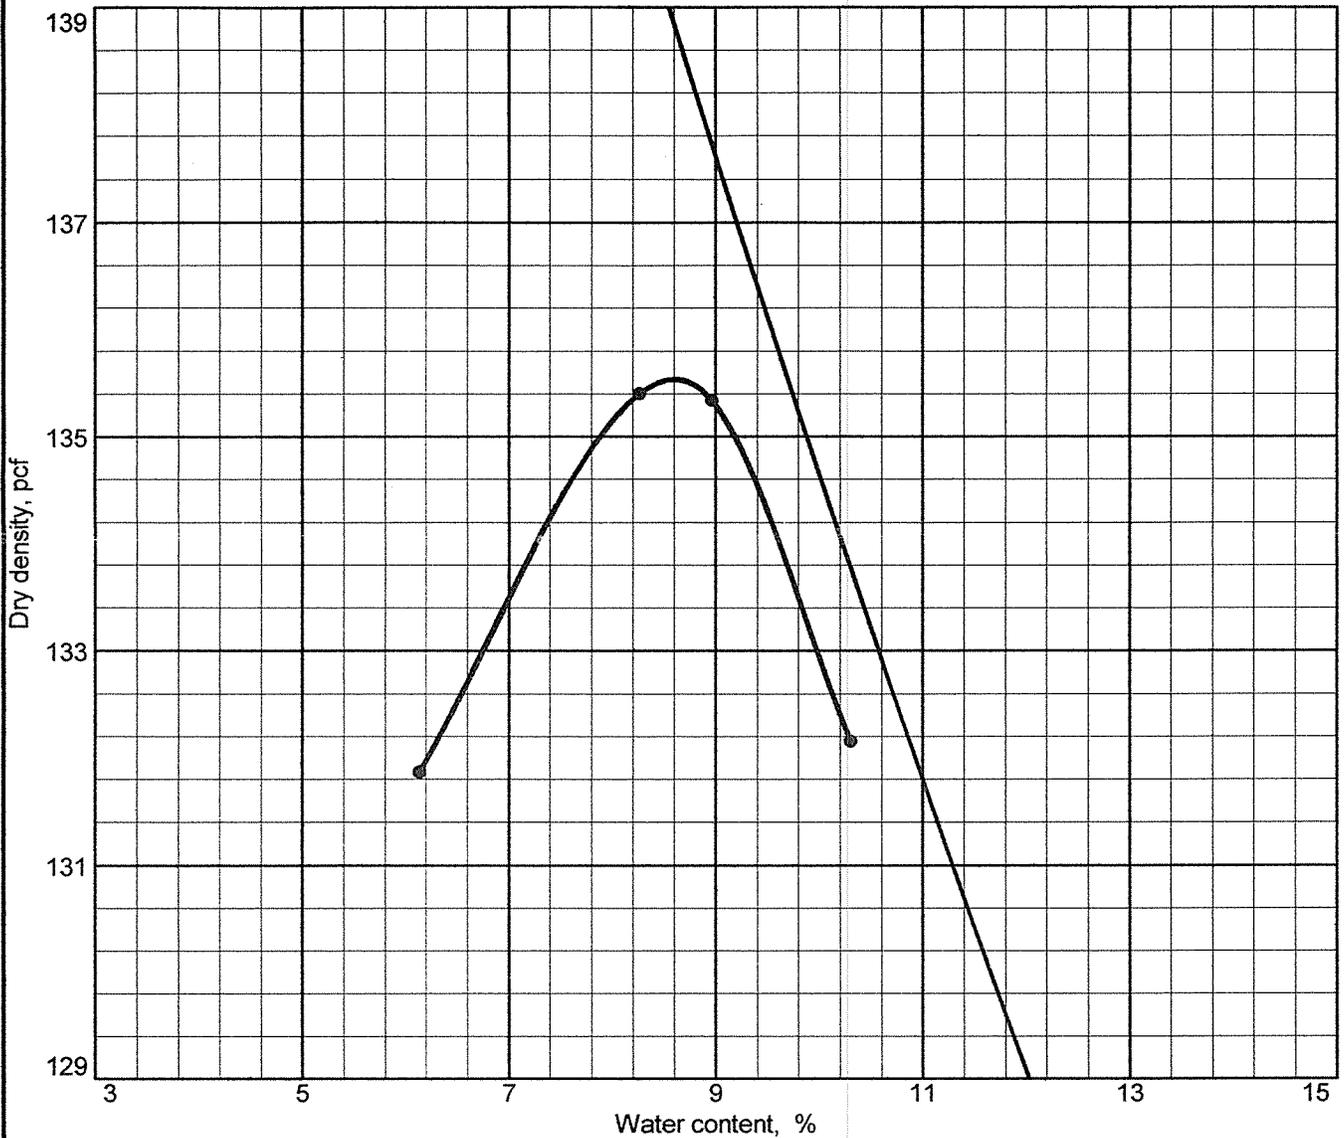
Test specification: ASTM D 1557-91 Procedure C Modified

TEST RESULTS	MATERIAL DESCRIPTION
Maximum dry density = 136 pcf Optimum moisture = 9 %	#2 Crusher Run Stone
Project No. RCH-01-394 Client: Day Environmental Project: Charlotte Street ● Source: On-site Material Sample No.: 01-1580	Remarks: Sample picked up by VanDerHorst on 11-15-01
COMPACTION TEST REPORT VAN DER HORST ENGINEERING	Figure Number 01-1580
